Re: FY 20 Guidelines for Brownfields Assessment Grants

NARRATIVE INFORMATION SHEET AND ATTACHMENT

FORT LYON FACILITY **30999 COUNTY ROAD 15** LAS ANIMAS, BENT COUTY, COLORADO

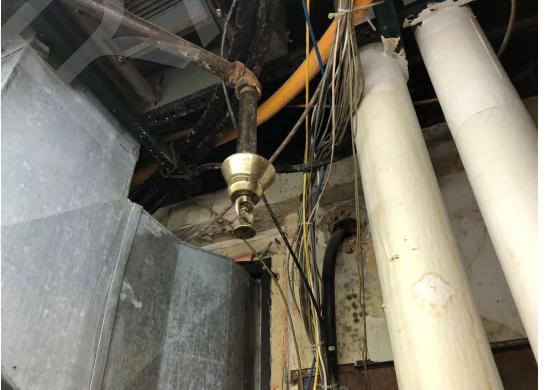
Asbestos pipe insulation observed in the basement of Building 3. Plaster in this room also has an asbestos compound present.
